ANNUAL REPORT

of the Rail
Accident and Incident
Investigation Unit

2020

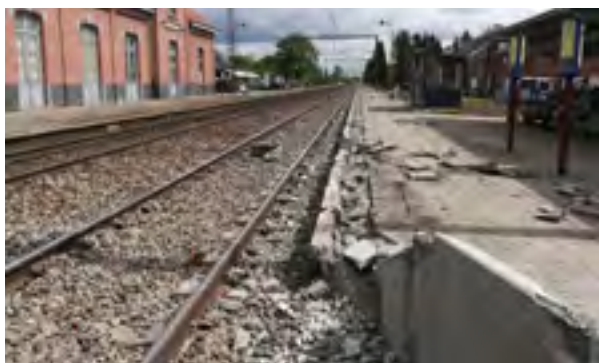
The driver does not feel or notice this breakage: the train continues its journey.

As a result of this breakage, parts of the wagon (parts of the bogie, parts of the brake system) are dragged, and various elements of the infrastructure are damaged (sleepers, level crossings, signalling elements).

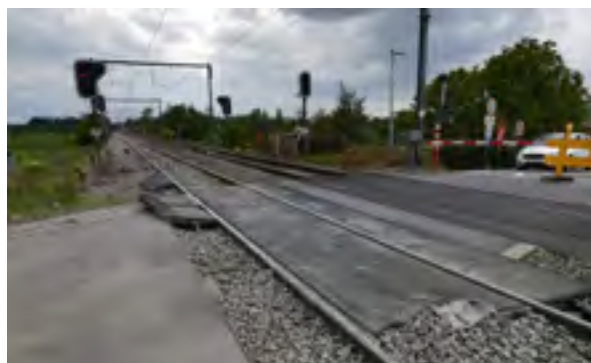
Ballast is also projected and causes damages to third party properties.

At Sinaai station, the 9th wagon - which is crabbing - scrapes elements of the structure of the platforms, causing significant damages.

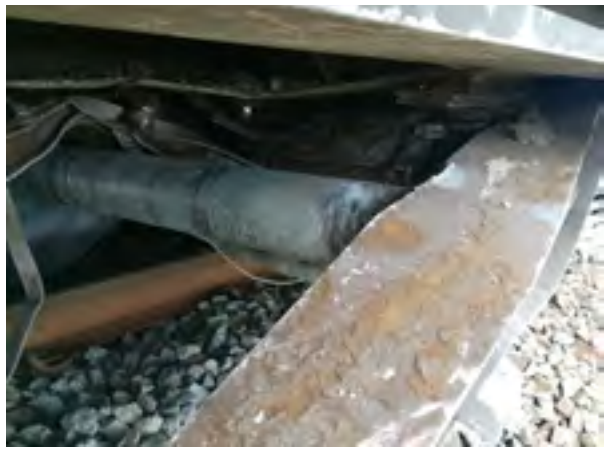
The derailment of wagon 31 80 2772 112-1 resulted from the breakage of the first axle of the leading bogie (in the direction of traffic).

- the axle breakage does not seem to be caused by a track component: the first signs of damage to the infrastructure were found in open track, in a straight track section without points and crossings;

- driving actions do not seem to have resulted in the axle breakage: locomotive records indicate that traction was active and that no braking action was performed;
- the load mass carried on the day of the accident does not seem to have caused the axle breakage: the load mass of the wagon exceeds the mass indicated on the consignment note by 1564 kg, but does not exceed the maximum allowable mass for the wagon load.
- the blow found very close to the initiation point appears to be a consequence of the accident.

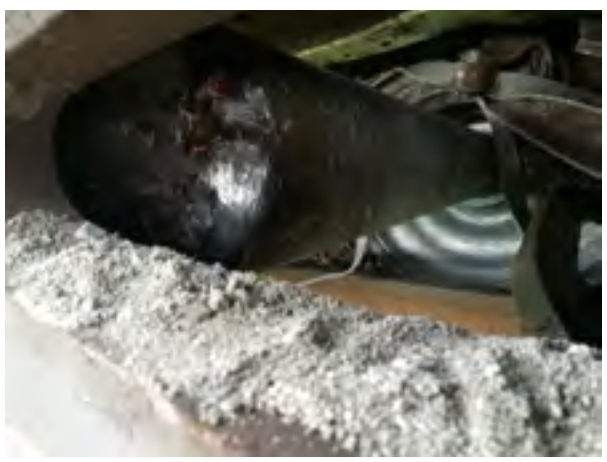
The axle failure is a fatigue failure, which is believed to be caused by the corrosion of the area identified as the failure initiation area, which is also subjected to high mechanical stress.

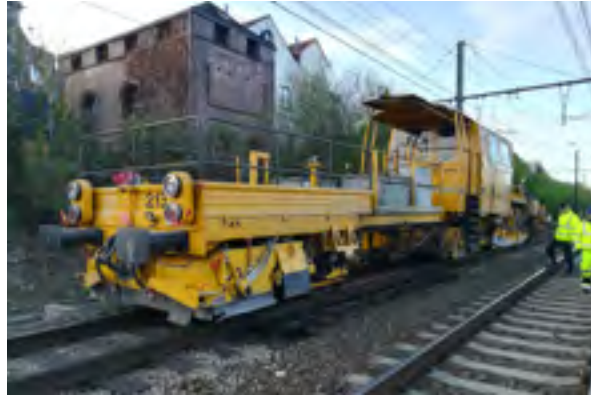
FINDING NO. 1

The cowl window was dirty and the diabolos were not visible. In the checklist provided for the inspection of track devices, there is no explicit indication to the inspection crews that they must ensure that the window glass under the cover in the cowl is clean enough to see through (particularly for a check on the position of the diabolos) and that they must clean it if necessary.

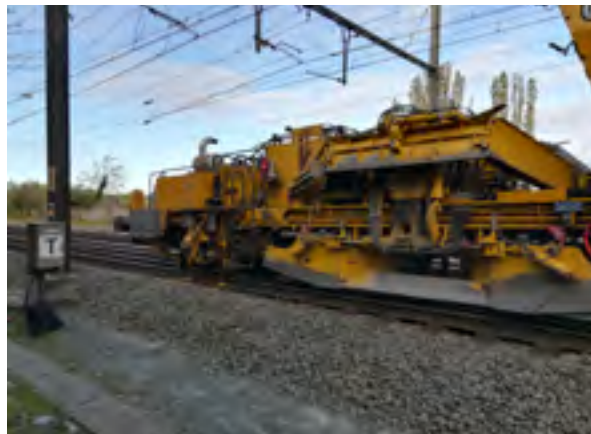
FINDING NO. 2

The track officer who performed the manoeuvre did not have A.R.E.T. safety duties. The switch manoeuvre was delegated to this officer by the work manager who had these safety duties and was therefore responsible for the organisation of this manoeuvre.

At the time of the accident, there was no formally defined procedure for the delegation of this manoeuvre. This delegation was nevertheless noted on the worksheet prepared for this service.
