Bulletin of General Information  
Derailment of a SNCB/NMBS passenger train  
Weerde  
28 January 2021

Derailment of a passenger train in open track.

Weerde, Line 27, about 800 metres in advance of Weerde station.

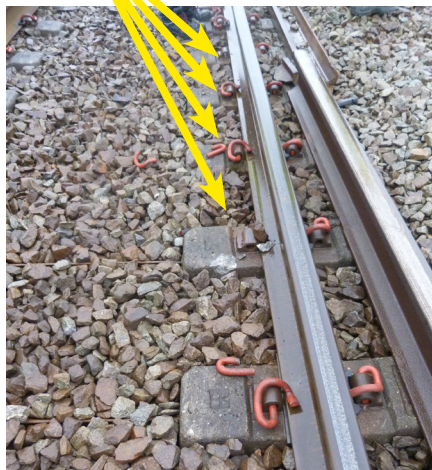
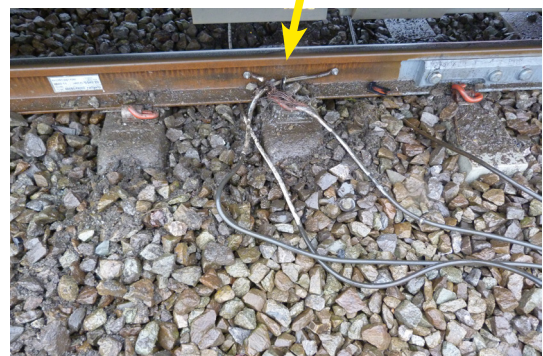
### Track damage

The damage is spread approximately between kilometre markers 17.200 and 17.500 with damage to Pandrol clips, shifted concrete sleepers, and destroyed railway cabling.

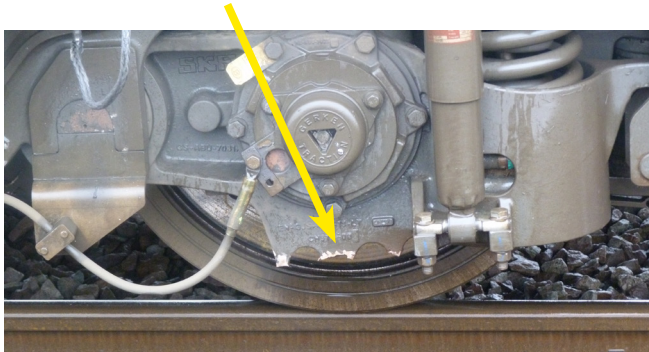
### Train damage

There is various impact and abrasion damage to the underside of the 1st bogie of AM8039: including broken parts of the axle bearing guide rod and twisted bolts.

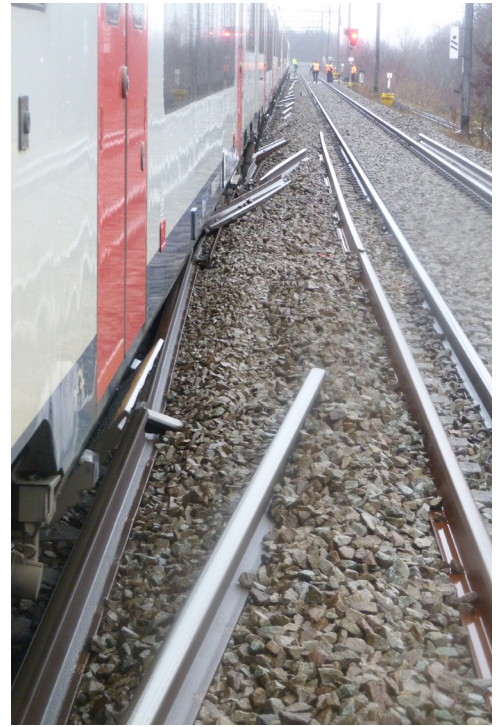
At kilometre marker 17.206 (about 800 metres in advance of Weerde station), the passenger train derails with the second wheelset axle of the first bogie. The first wheelset axle remains on the rails. At 6:13 a.m., the train driver initiates an emergency braking, bringing the front of the train to a standstill at kilometre marker 17.427.
