ANNUAL REPORT

of the Rail
Accident and Incident
Investigation Unit

2020

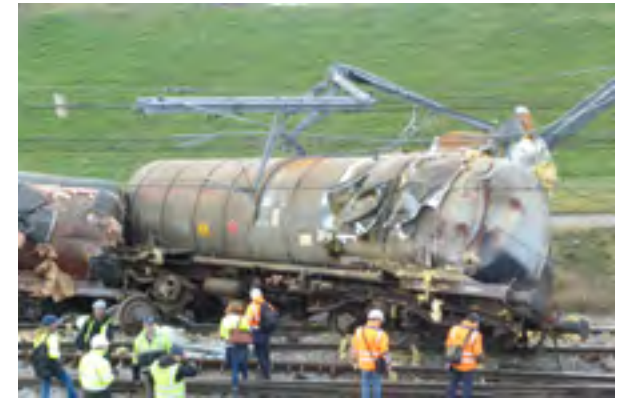
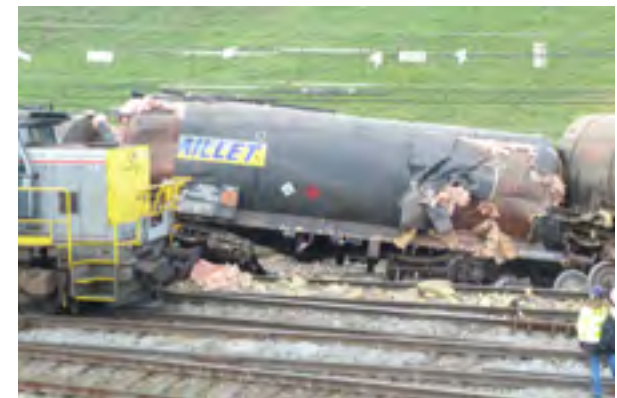
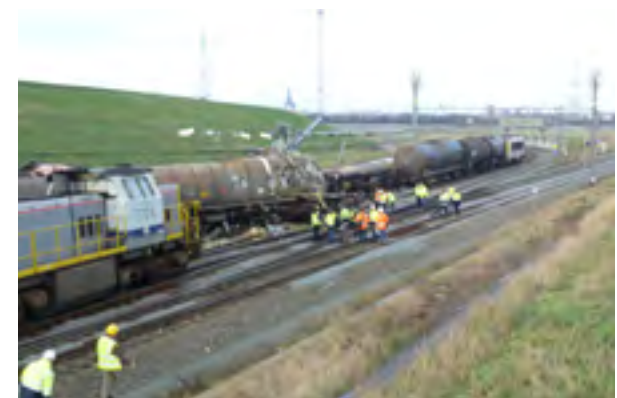
Upon impact, six wagons of the E49826 train derail. Wagon number four separates and overturns completely. The residue inside the wagon leaks out. There is no immediate fire risk. Wagons number five and six partially overturn, derail towards the verge and

start jack-knifing. Upon impact, the LZ70080 train's diesel tank also starts to leak. The first engine's driver's cab is severely damaged.

The train conductor of the LZ70080 train sustains a minor injury to his hand. The train conductor of the E49826 train emerges unscathed.

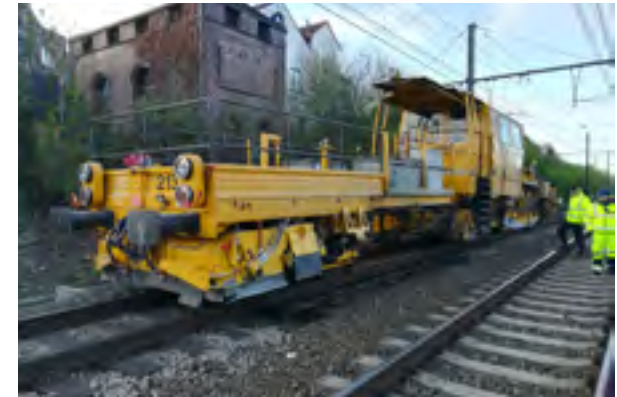
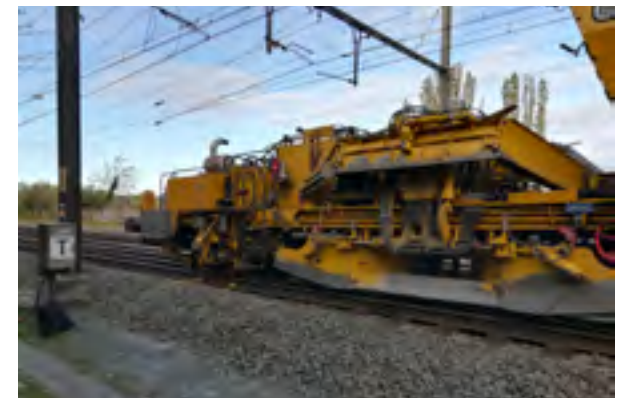
The derailment caused damages to the infrastructure and the ballast regulator, as well as a stoppage of rail traffic for more than six hours.

There were no victims.

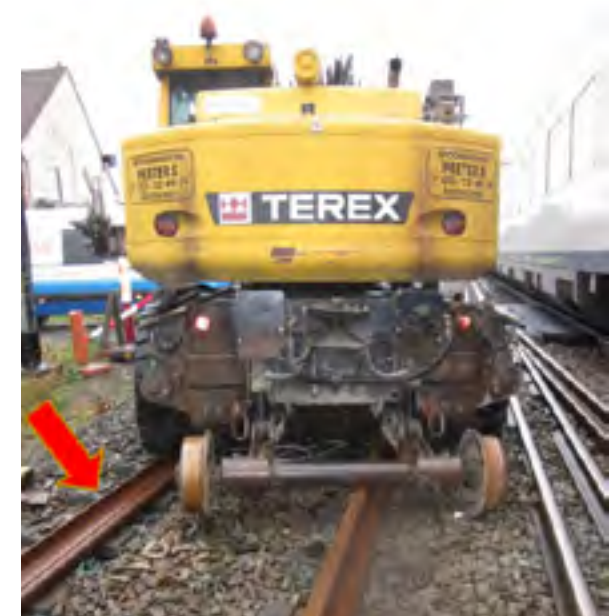
The **direct cause** of the accident was the intrusion of the crane jib into the adjacent track's loading gauge and the train's ability to enter this zone without an effective safety method being activated.

The **first underlying factor** is the lack of fully developed procedures on the part of the infrastructure manager for the choice, dissemination and application of the specific safety methods, which should take account of dynamic working conditions such as the transition from one safety method to another, among other things.

A **fourth underlying factor** is the limited consideration given in the infrastructure manager and the contractor's training sessions to dangers and risks related to a change in operational circumstances.

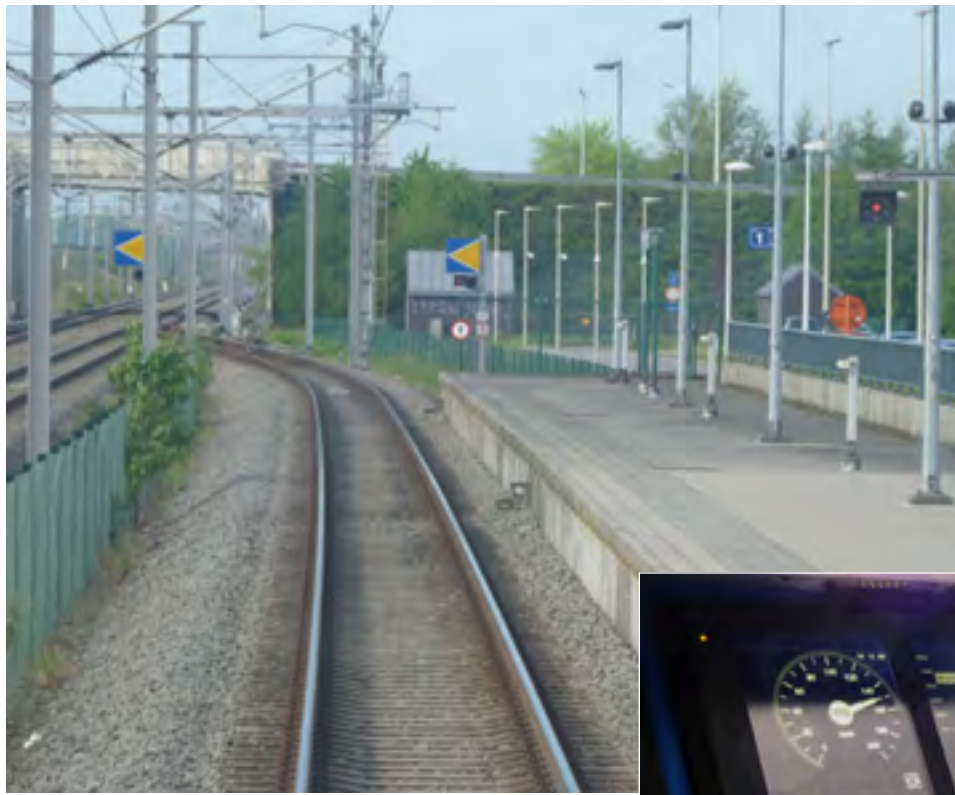
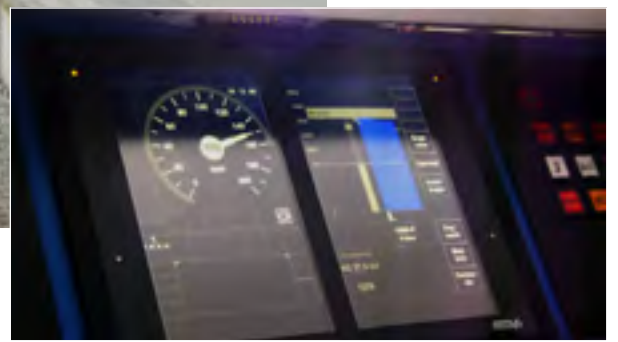
The **direct cause** of the train running through switch O2W in Noorderkempen is the inability to stop train E15214 (ETCS 1) in time in rear of stop marker board C-W.12 on HSL 4 (ETCS 2 with fallback in ETCS 1), due to a combination of 3 factors:

The **second indirect factor** is the train driver's failure to identify a doubtful situation in time.

The **sixth systemic factor** is a lack of traceability in the decision taken. Due to a lack of traceability, it is no longer possible to verify until when the 'conditions' were complied with and why they were no longer complied with. Due to a lack of traceability, it is also no longer possible to verify why the reference to 'conditions laid down by the Infrastructure Manager' as stated in the Ministerial Decree of 2008 was no longer mentioned.
